## **Rio Puerco Mine**

## AUM Field Survey Data Sheet

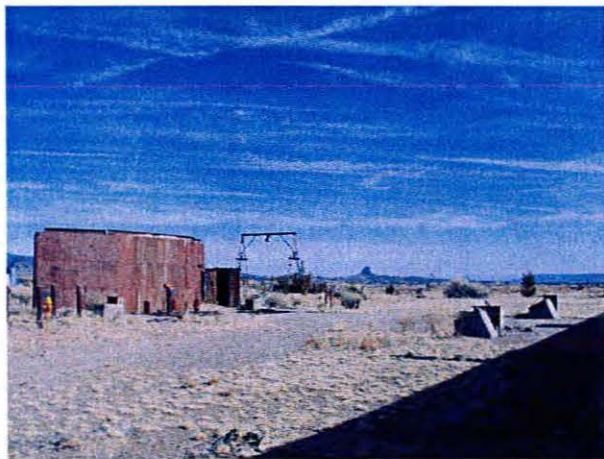
Headframe area

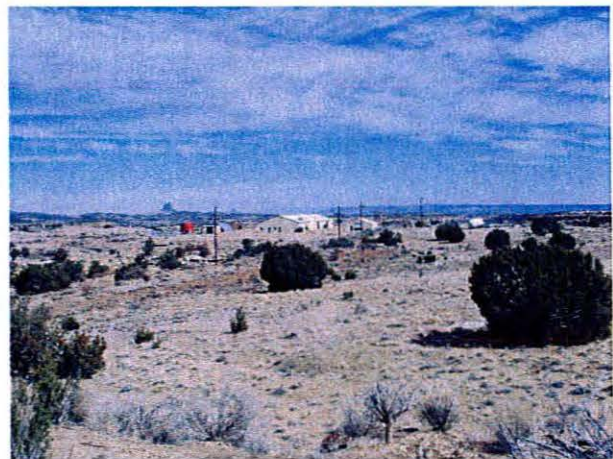
Site view

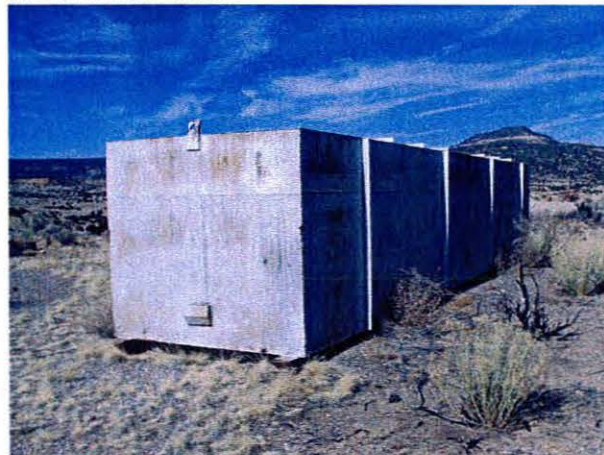
Storage containers

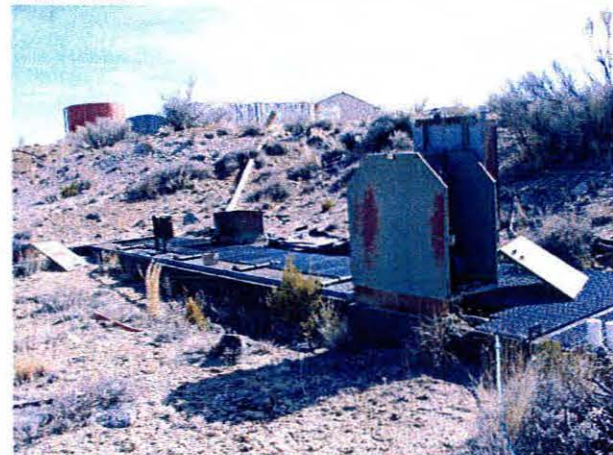
Pump station

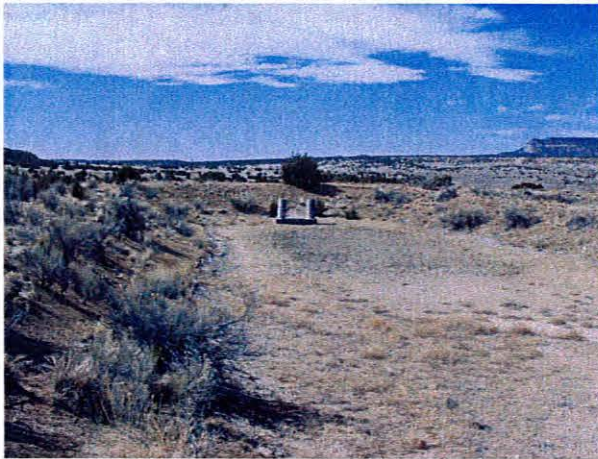
View south into eastern-most pond

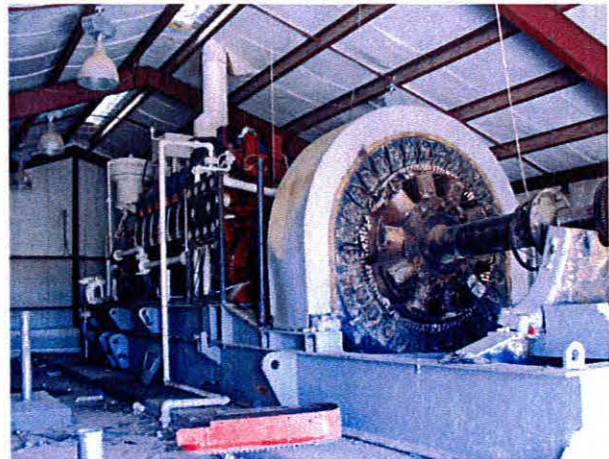
Interior of building

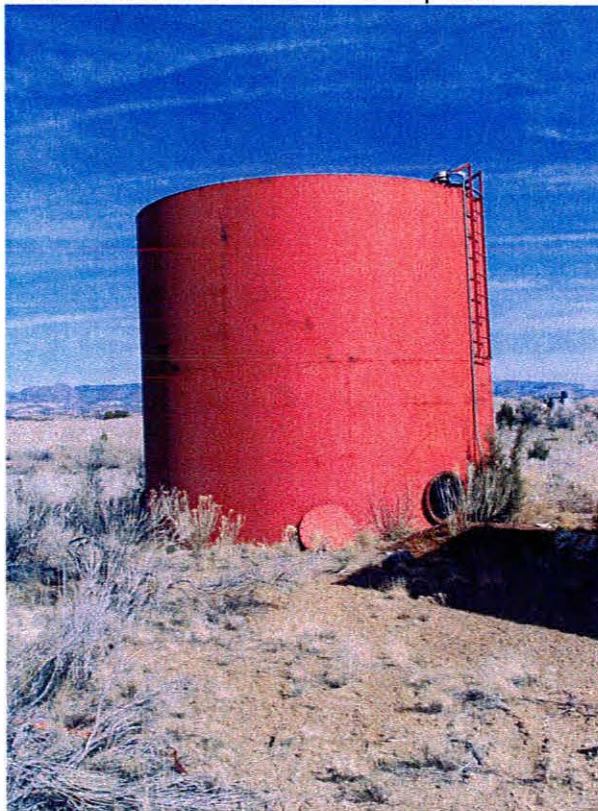
Water tank

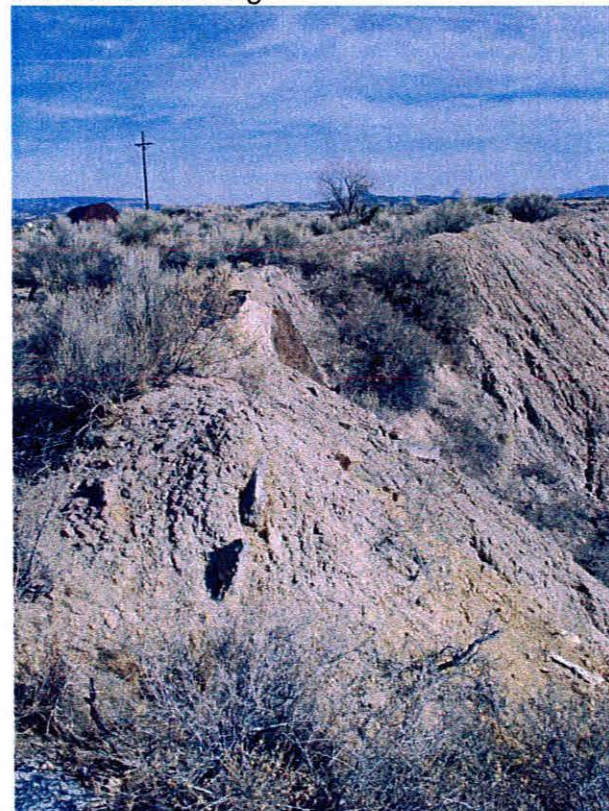
Rock piles

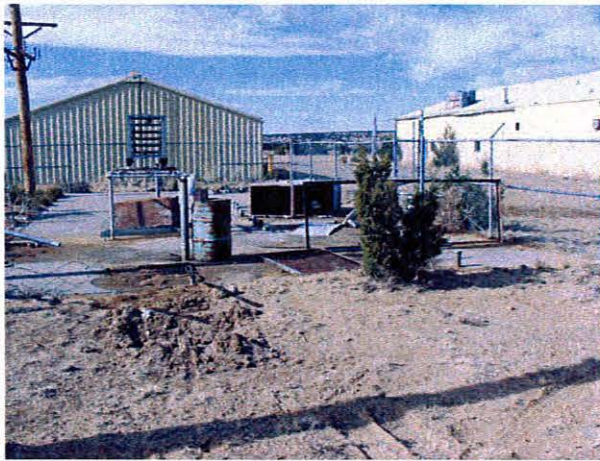
Electrical yard with transformer oil spill

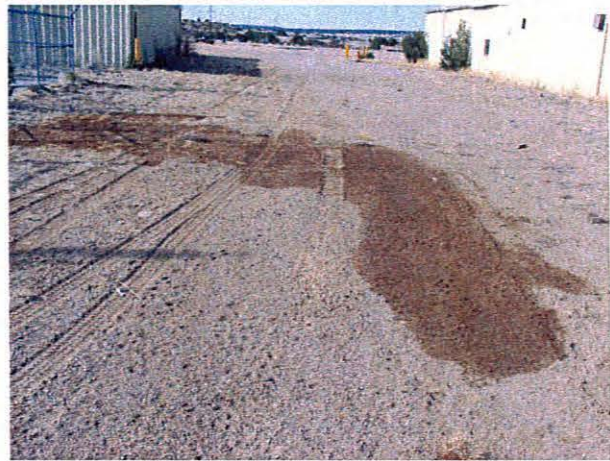
**2. Human Activity:** Fresh tire tracks indicate recent human access to the site.

Transformer oil spill, recent tire tracks
